# ECHO & SEYMOUR LAKES WATERSHED ACTION PLAN

## FINAL REPORT

**DECEMBER 2024**

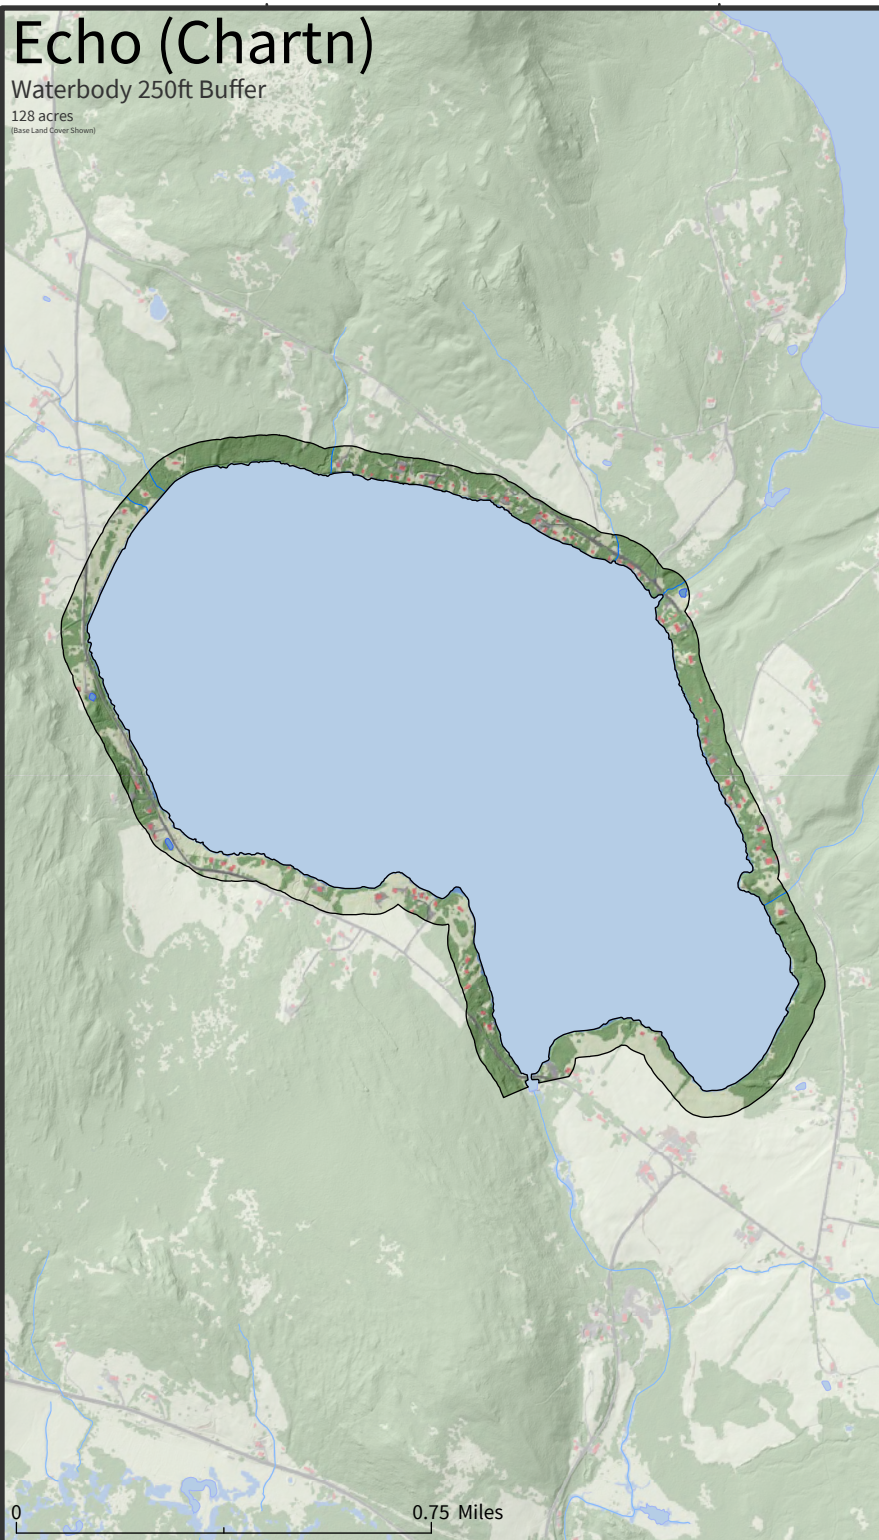
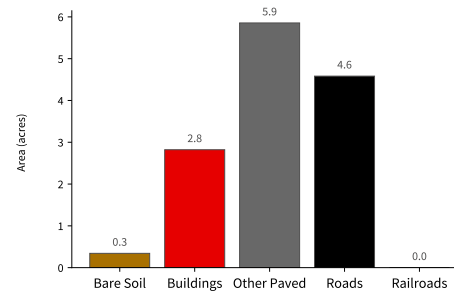
## High-Resolution Land Cover Summary **FIGURE 5**

Waterbody 250ft Buffer  
128 acres  
(Base Land Cover Shown)

#### Impervious Surfaces (13.6 acres - 10.6% of total) (Bottom-Up\*\*)

#### Agriculture (11.44 acres - 8.9% of total)

#### Wetlands (25.55 acres - 20% of total)

#### Tree Canopy (74.39 acres - 58.1% of total)

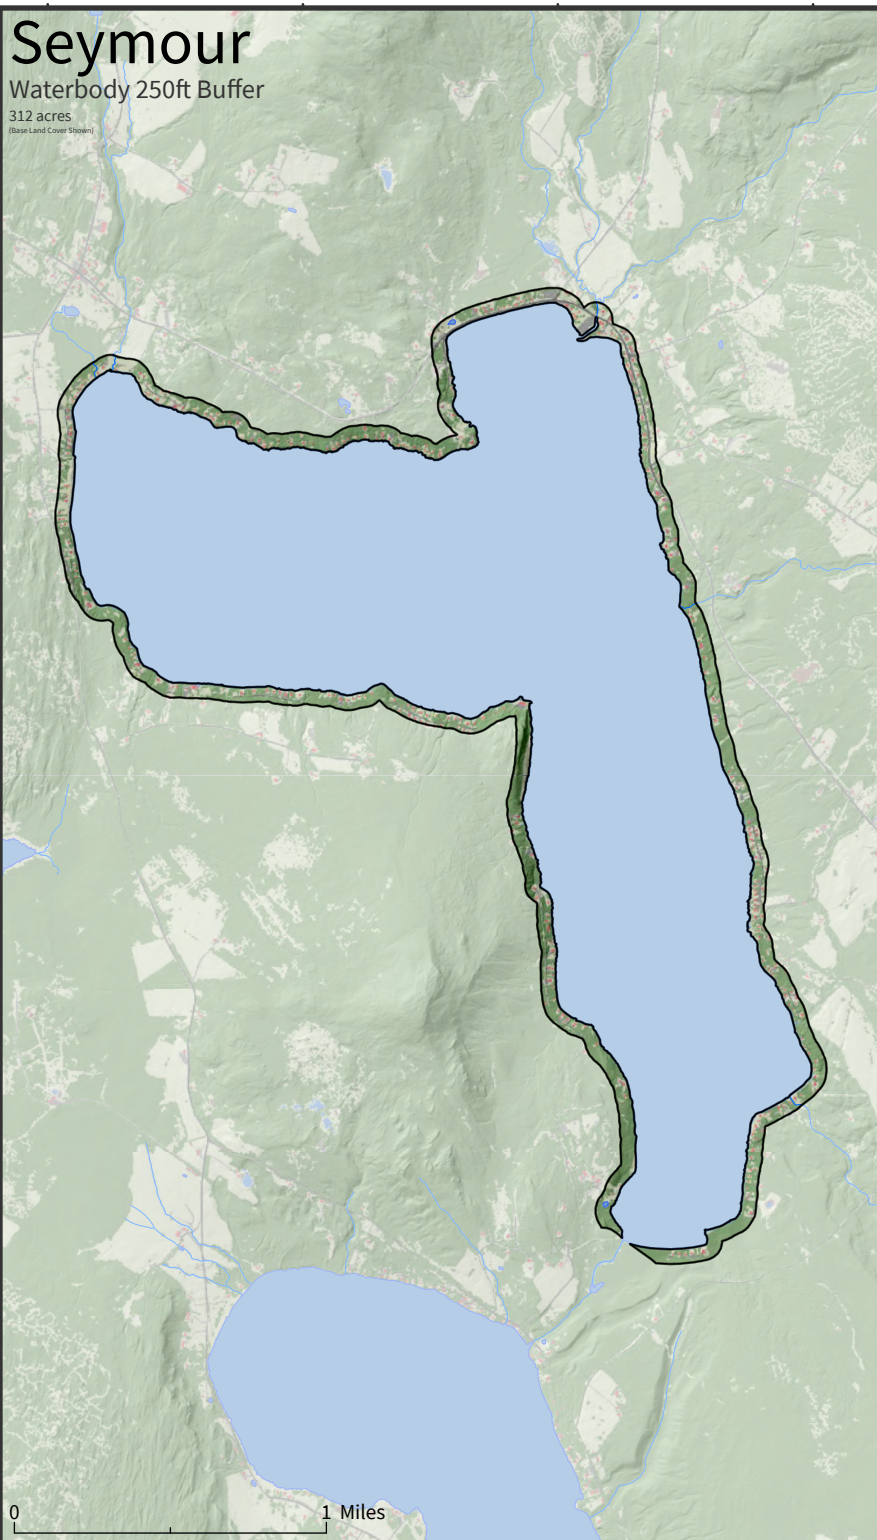
## High-Resolution Land Cover Summary **FIGURE 6**

312 acres  
(Base Land Cover Shown)

#### Impervious Surfaces (44.7 acres - 14.3% of total) (Bottom-Up\*\*)

#### Agriculture (2.71 acres - 0.9% of total)

#### Wetlands (35.28 acres - 11.3% of total)

#### Tree Canopy (195.75 acres - 62.7% of total)

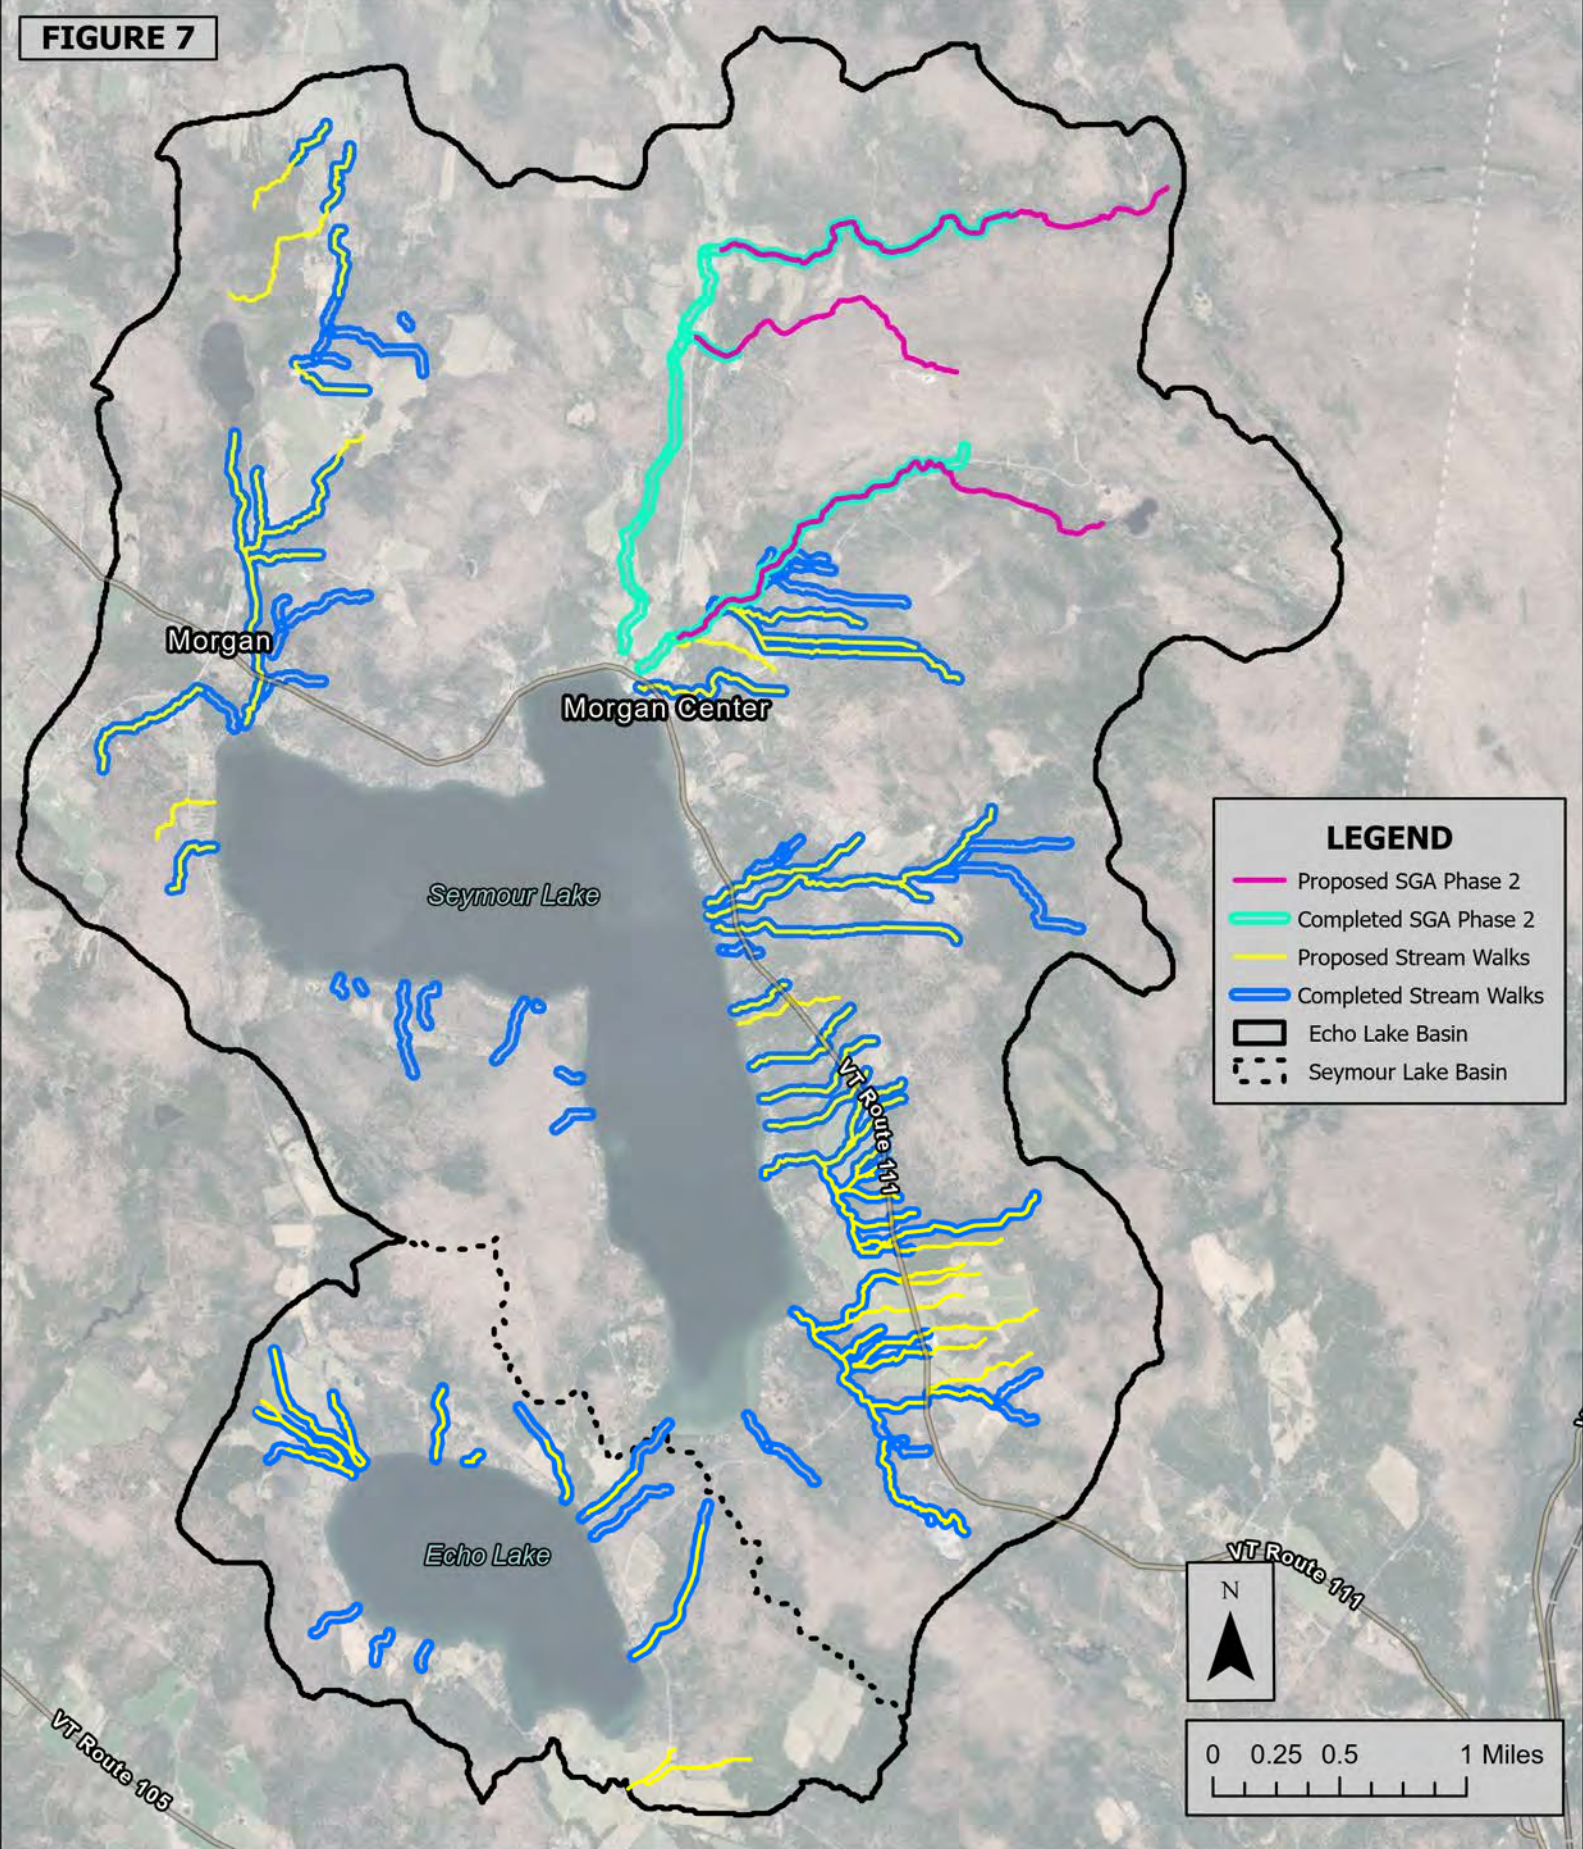
**FIGURE 7**

**Notes:** Map depicting locations of proposed & completed StreamWalks & Phase 2 Stream Geomorphic Assessments.

**MWA conducted stream walk assessments along 32.3 stream miles and across 213 individual properties** (Figure 7). More than 500 field observations were collected during SGA and Stream Walk assessments. Assessments were performed on foot, typically from downstream to upstream, and extended laterally up contributing gullies, ephemeral drainages, or other areas where water quality issues were suspected. Observations were recorded in the field using an ESRI Field Map™ customized by MWA for the Echo-Seymour watershed. Each record included GPS location, observer name, date/time, description, notes, and photos (if applicable). Where discrete potential water quality or habitat improvement projects were identified, a Potential Project Summary Sheet was created in the field using an ESRI Survey123™ form generated by MWA. This digital field form included a project name & identifier, location and property information, description of the problem/opportunity, potential BMPs or other remedies, possible co-benefits, relevant measurements and metrics (e.g., length, width, & depth of a gully), photos, and other

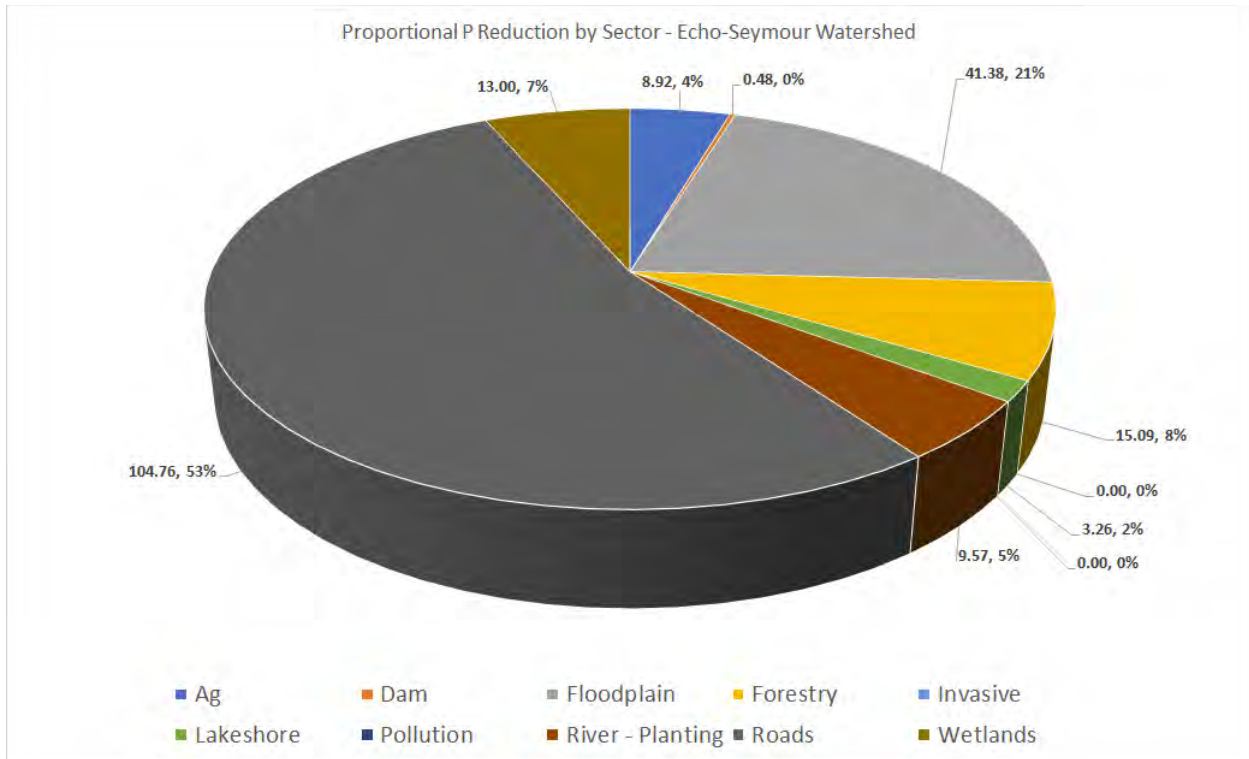
When using this approach and considering the watershed as a whole, public and private road projects have the potential to reduce P loading by 104.75 kg/yr or 53% of the total reduction potential identified across all project types in this LWAP. The stream/floodplain projects contribute approximately 21% of excess P loading (41.38 kg), followed by forestry projects (15.1 kg/yr; 8%) and wetlands projects (13 kg/yr; 7%). Agricultural projects (8.92 kg/yr) and river-planting projects (9.57 kg/yr) each contribute approximately 5% of excess P loads to the watershed. Minor contributions were also observed from the lakeshore projects (3.26 kg/yr; 3%). Invasive species control and pollution abatement projects did not receive any P reduction values and, as such, do not contribute excess P loads to the watershed.

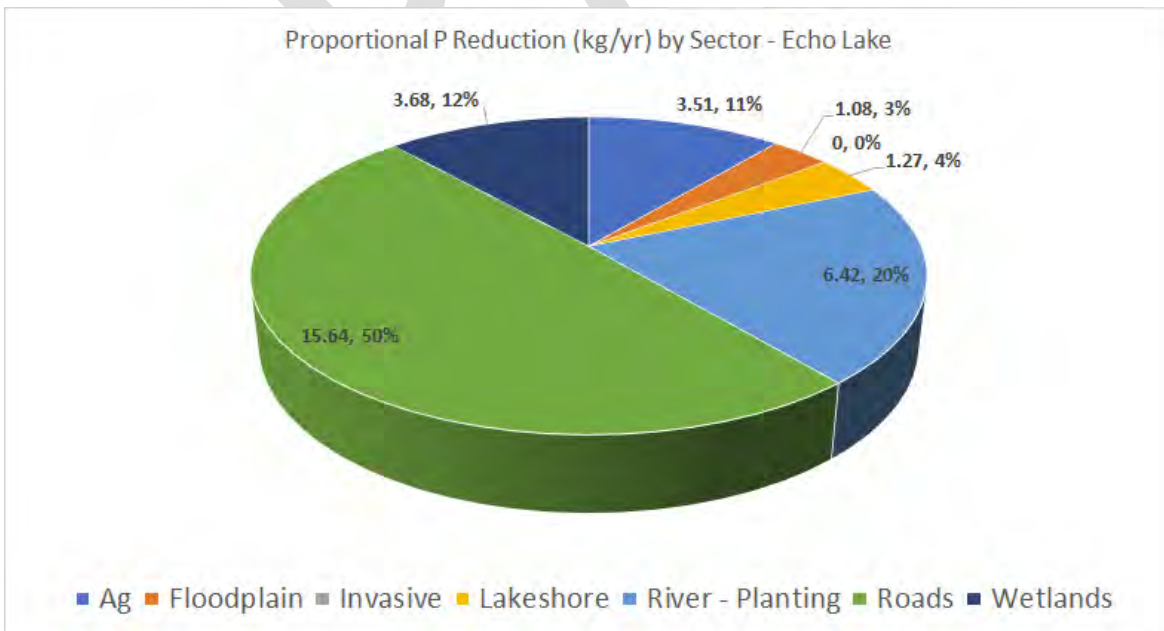
In the Echo Lake direct drainage, public and private road projects again account for approximately half of the excess P loading (15.64 kg/yr; 49%). Around Echo Lake, river-planting projects contribute 20% (6.42 kg/yr) of excess loads, followed by wetland projects (3.68 kg/yr; 12%) and agricultural projects (3.51 kg/yr; 11%). Potential lakeshore projects (1.27 kg/yr; 4%) and floodplain/stream projects (1.1 kg/yr; 3%) contribute relatively minor excess P loads.

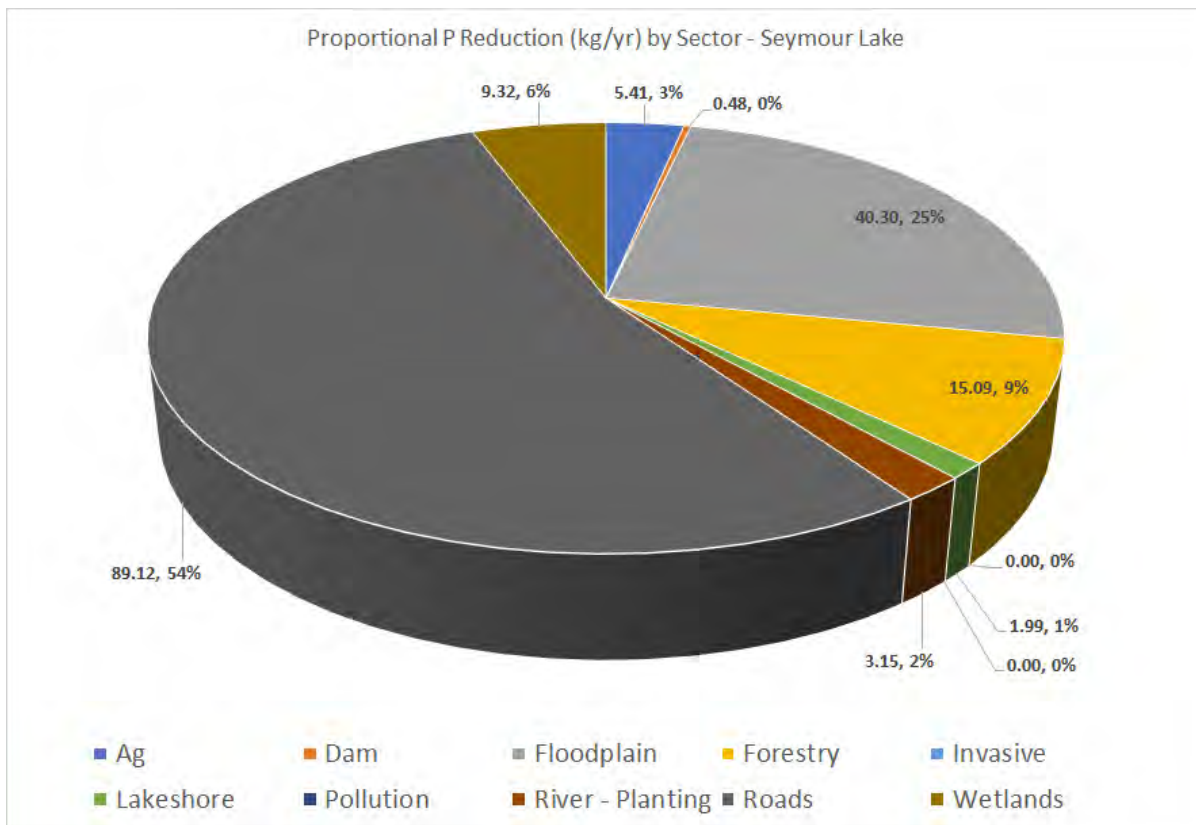
Similarly, public and private roads are the most significant sources of excess P loading to Seymour Lake. Here, road projects contribute 54% (89.1 kg/yr) of the excess P loads, followed by floodplain/stream

projects (40.3 kg/yr; 24%), forestry projects (15.1 kg/yr; 9%), and wetland projects (9.3 kg/yr; 6%). Agricultural projects were found to be relatively small contributors of excess P loads (5.4 kg/yr; 3%), much like river-planting projects (3.2 kg/yr; 2%) and lakeshore projects (1.99 kg/yr; 1%).
